### Regional District of Kootenay Boundary

#### Christina Lake Water Utility Source Water Protection Plan

NOVEMBER 2019

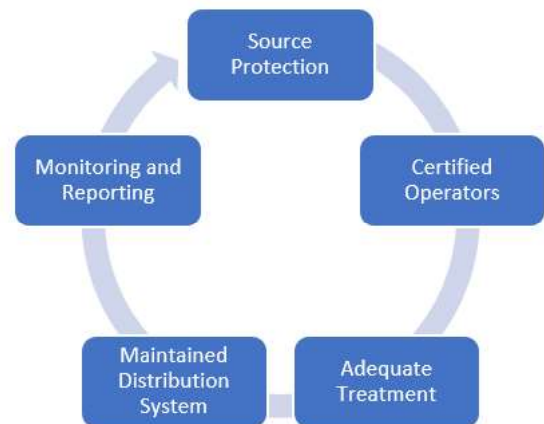
Figure 1: Components of the multi-barrier approach to delivering safe drinking water

A Source Protection Plan is one important part of a multibarrier approach to provide safe drinking water. Figure 1 illustrates the five main components of a plan. The objective of a Source Protection Plan is to identify threats to drinking water safety, and to develop recommendations to reduce risks and improve the resiliency of the water supply.
